## Site Features Inventory Report

**Barite Hill Mine  
McCormick, South Carolina**

Prepared By: Michael Gobla, P.E.

July 2007

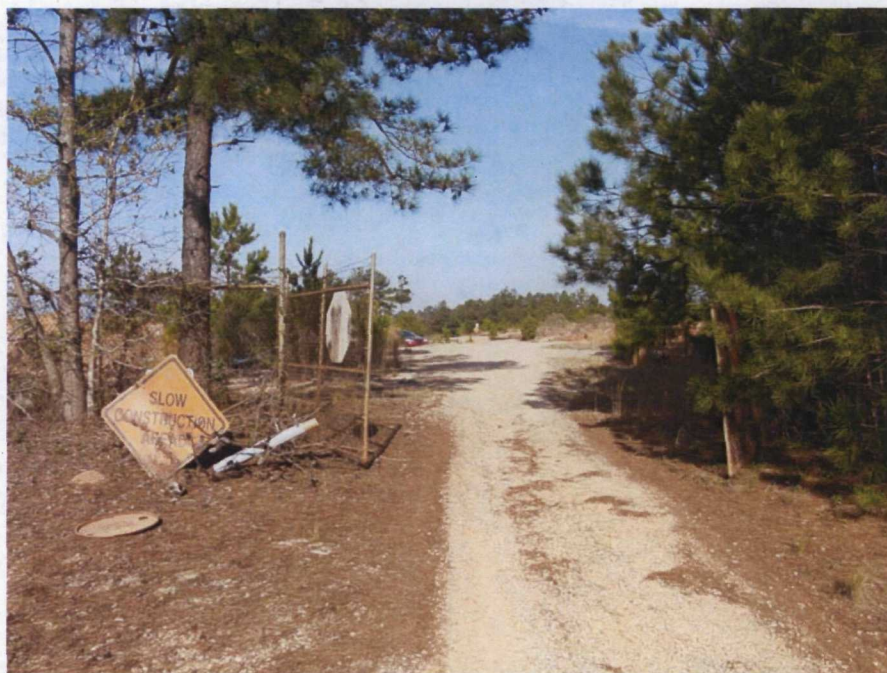
**Figure 4.** Photograph of the access gate near the mine office. A similar gate lies to the east at the site entrance.

Two access gates are located on the main entrance road. One is on the east side of the site near the mine entrance just off road 30. The other gate (see Figure 4) is near the center of the property just east of the principal mine disturbed areas and is adjacent to the mine office building. The gates each consist of two 10-foot swinging units providing an opening of approximately 20 feet at the mine entrance and a 19.5-foot-wide opening in the gate adjacent to the mine office building.

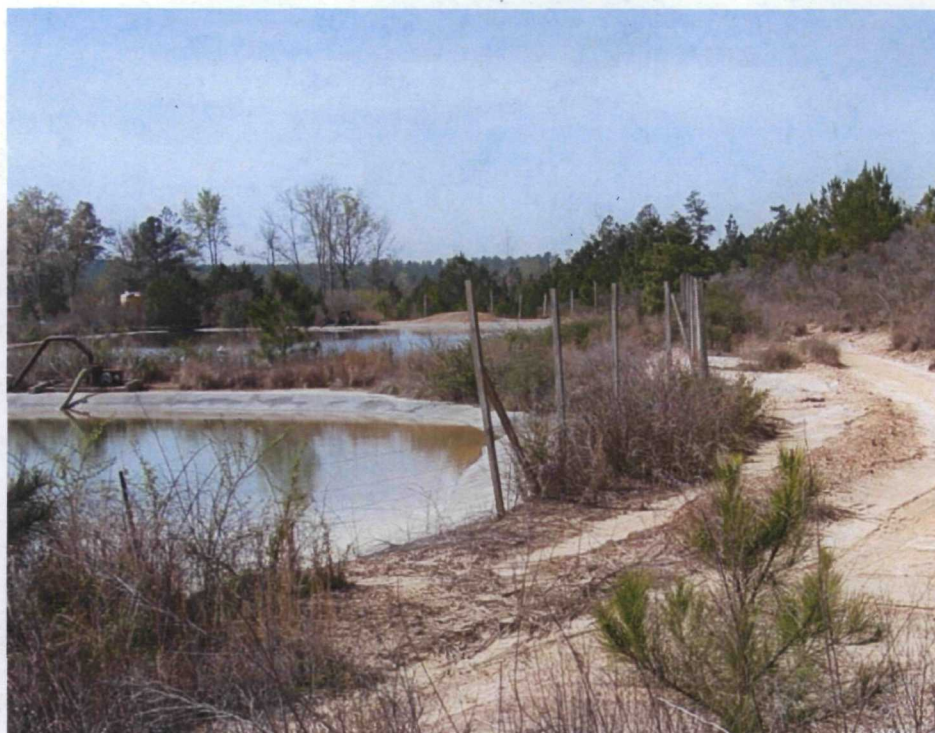
**Figure 6. Photograph showing a transition in the fencing at the Permanent Heap Rinse Pond. At left is a three strand barbed wire fence, at right is the taller fence with a smooth wire grid and upper strands of barbed wire.**

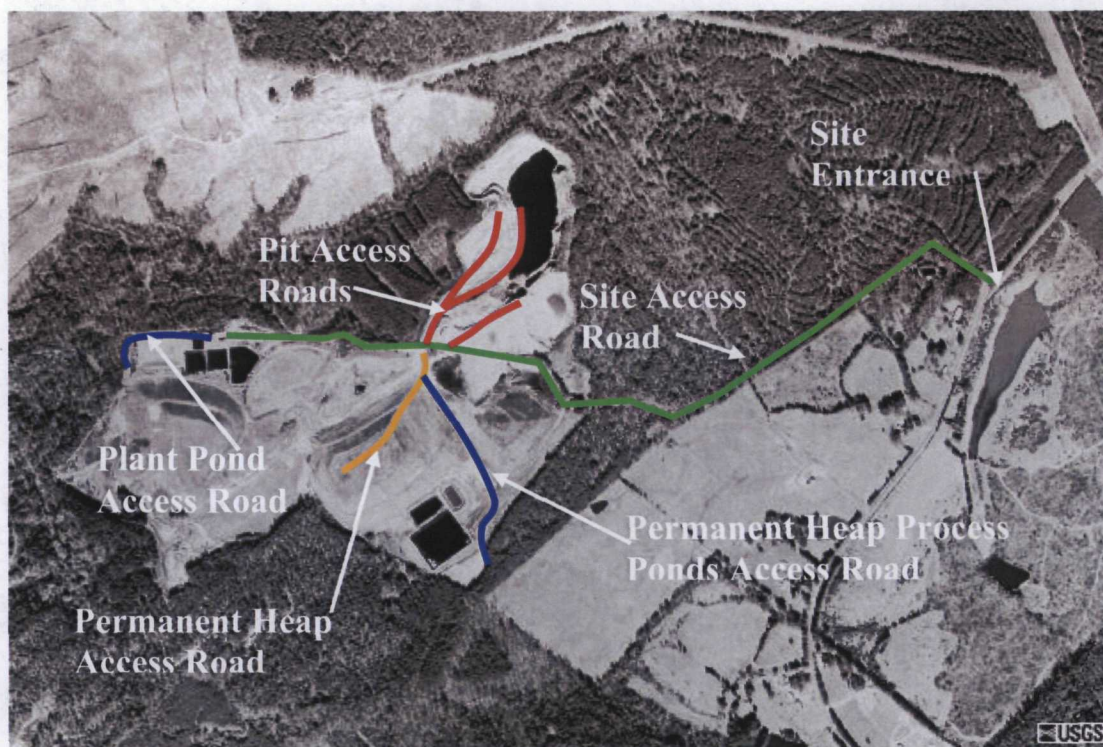
**Figure 8. Aerial photograph of the Barite Hill Mine showing existing access roads.**

The site access road is 20 feet wide over most of its length, but is about 30 feet wide adjacent to the mine pit. The other site roads are 10 to 12 feet wide and are being encroached by growth of the adjacent vegetation. The access road leading to the Permanent Heap Process Ponds requires trimming of the vegetation if it is to stay open to vehicle movement. Except for a very short segment of broken pavement in the site entrance where it connects to road 30, the site roads are not paved. The Permanent Heap Process Ponds Access Road is being encroached by vegetation and requires brush removal if it is to remain open. The Pit Access Roads are littered with large rocks and can not be traversed by passenger vehicles.

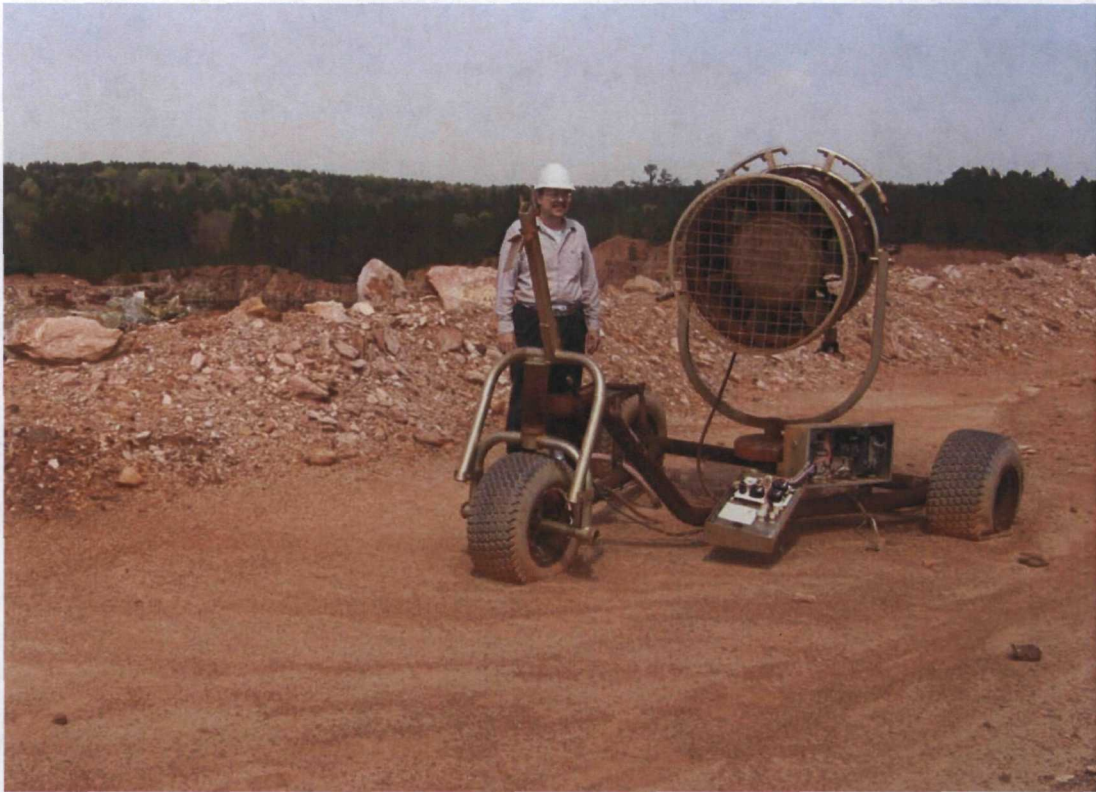
Volunteer vegetation is not seen on the south side of the pit even though the soil and rock appears to be oxidized. A snow making machine was used along the south highwall to evaporate excess water from the pit (Figure 11). The mist fallback from the device would have contaminated the ground with acid salts which would inhibit vegetation establishment for a time; but now these salts should have been flushed from the soil. It is likely that the south highwall is too far away from existing vegetation for any seed to have been deposited in this area.

**Figure 11. Snow making machine on top of the south highwall was used to evaporate excess site water.**

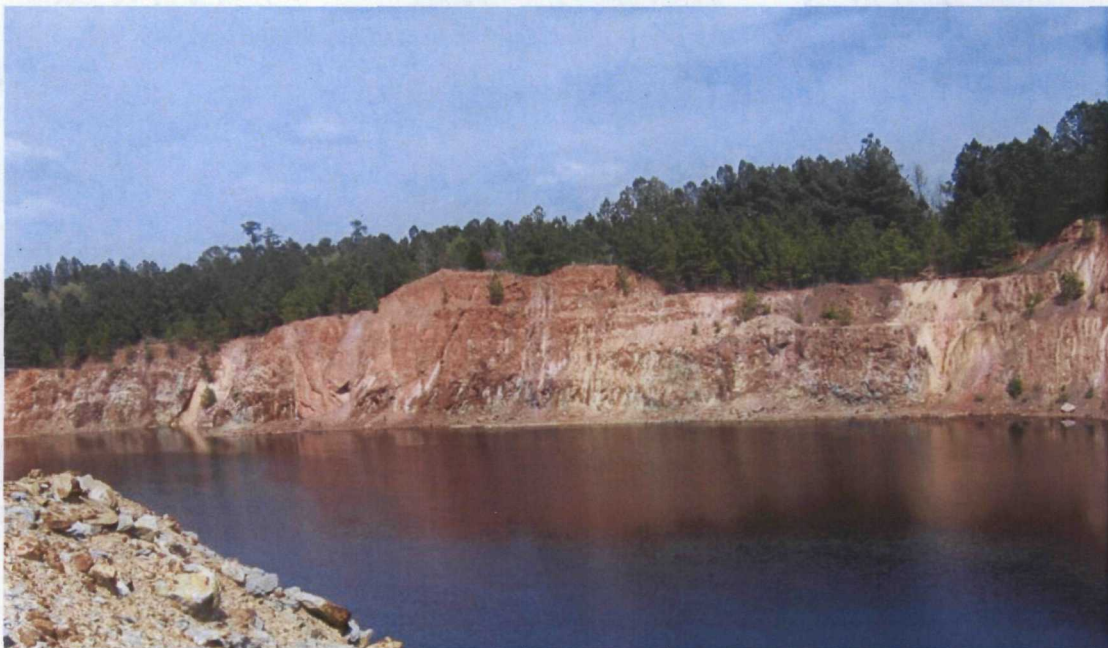
The un-oxidized material is the grey- to yellow-colored rock which is rich in pyrite and is highly acid generating. This material is evident in the northeast, north and west sides of the pit highwalls (see Figures 12 and 13). Additionally, pyrite-containing waste rock has been dumped onto the gently sloped bench areas on the west side of the pit (see Figures 14 and 15), and is a major acid source area draining into the pit.

**Figure 12. Photograph of the highwall on the northeast side of the pit. The grey to yellow rocks in the highwall are acid generating rock. The red colored rocks and overlying soil likely do not generate acid and show volunteer vegetation.**

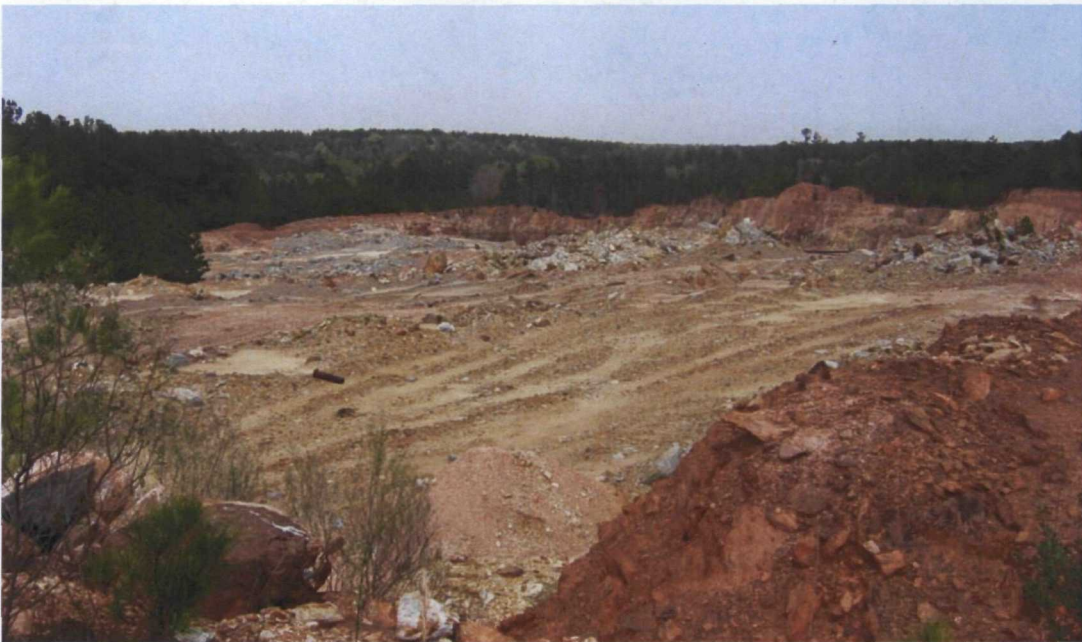
**Figure 14. Photograph showing the disturbed area on the southwest side of the Barite Hill Pit. This is a major source area for acid water draining into the pit.**

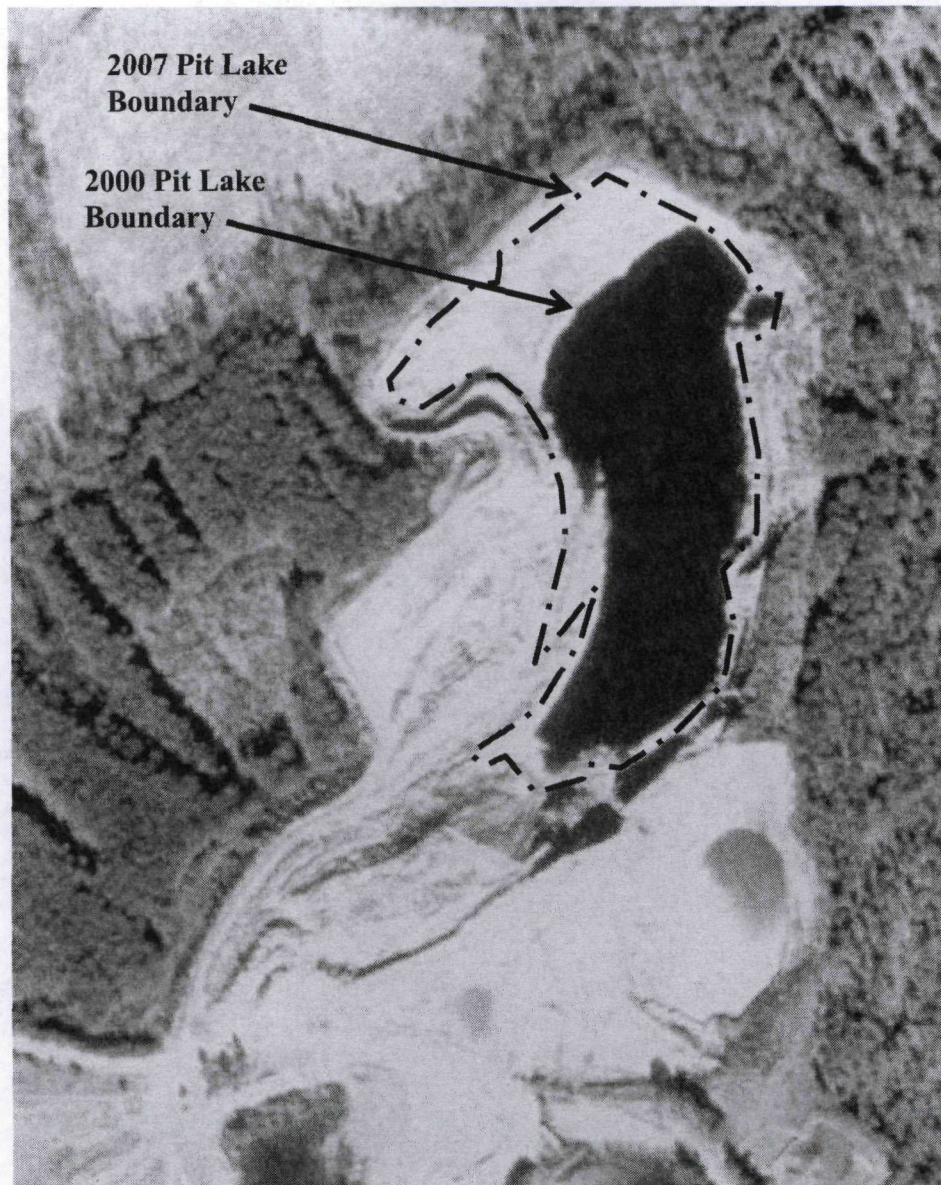
At Barite Hill the water level in the pit is presumed to have been rising since the mining activity ceased in mid-October, 1994. It is presumed that the pit began filling as soon as mining ended. There would be no incentive to keep water out of the pit after all of the ore had been extracted. The aerial photograph shown in Figure 17, shows the pit lake as it appeared in the year 2000 which would have been 6 years after the end of mining. Also, water in the pit appears to have increased up to the present time. The approximate extent of the pit lake as it currently exists has been added to the aerial photograph shown in Figure 17.

**Figure 17. Aerial photograph of the Barite Hill Pit in the year 2000 showing the pit lake about 6 years after mining ended. The pit lake boundary in 2007 (about 12 years after mining ended) has been drawn onto the image.**

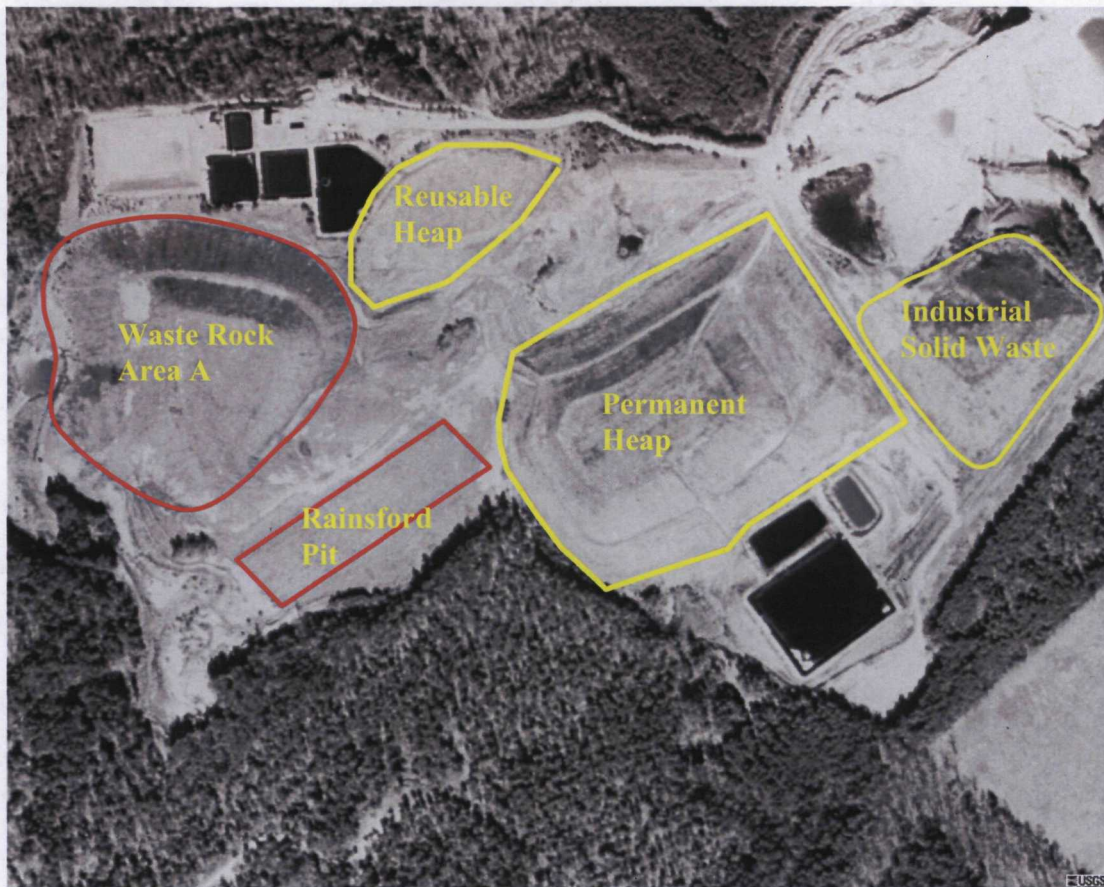
**Figure 19. Aerial photograph of the Barite Hill Mine process areas showing waste rock and spent ore repositories.**

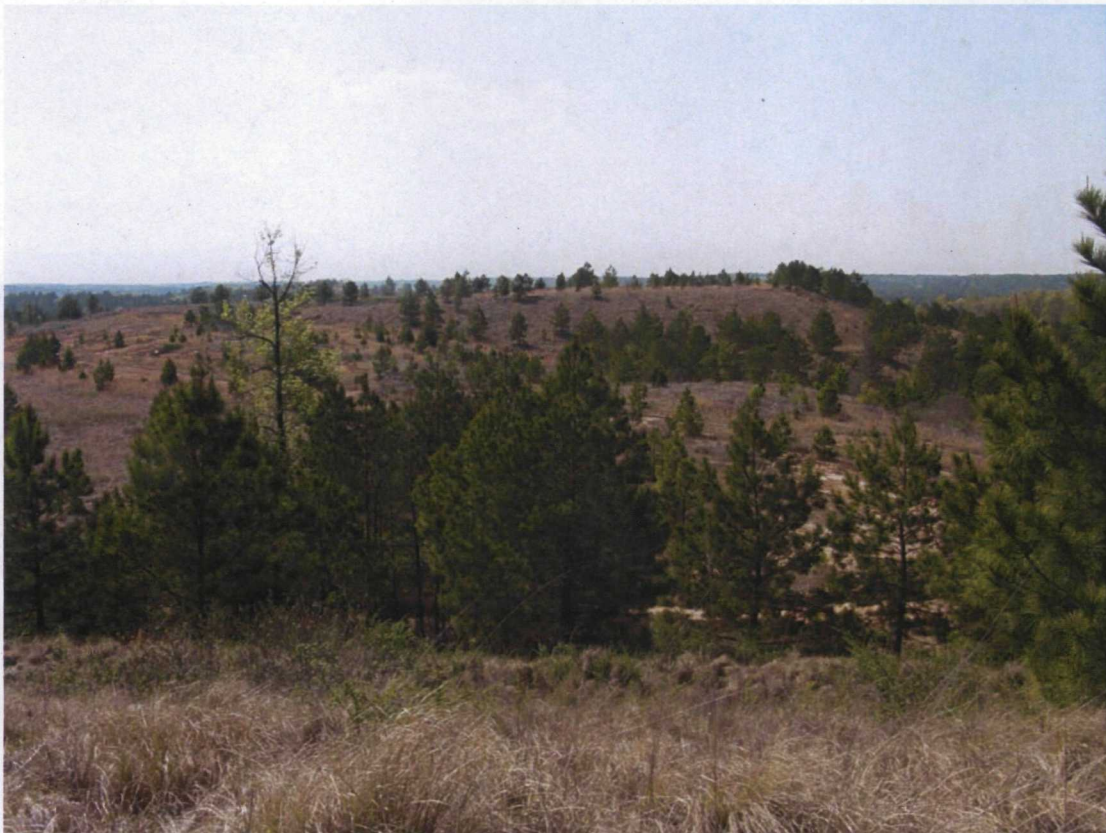
Waste Disposal Area A covers 17 acres and has been capped with clay, cover soil and is vegetated. An area of dead vegetation was observed on the north side of the repository. The cause is believed to be acid and metals toxicity, but, no active acid seep was evident. It is likely that there is a small acid seep which is active during wet conditions. The perimeter diversion ditch on the north side of the repository has eroded its channel and further upstream on the northeast side the same ditch is actively headcutting. The banks

**Figure 20. Photograph of the east slope of Waste Disposal Area A which is the high ridge line in the distance. View is from the Permanent Heap Leach Pad looking to the west.**

are vertical and will soon begin to erode and gully. The gully action will eventually extend from the ditch banks up into the capped area and will degrade the cap. These ditch banks must be stabilized to protect the integrity of the cap. The top, west, and south sides of the repository were not inspected. It is understood that the former "Sediment Dam A" structure built on the west side of the repository has been removed and that a small sediment pond remains which is being allowed to silt in. Downstream from this facility is a beaver pond which is capturing sediment and water flowing from this portion of the site. It is concluded that this repository is turning acidic and may become a significant source of acid seepage in the future. Acid seepage is likely to be greatest on the west side where the bedrock forms a low point. Maintaining the integrity of the cap is essential to minimize the rate of acid discharge from this repository.

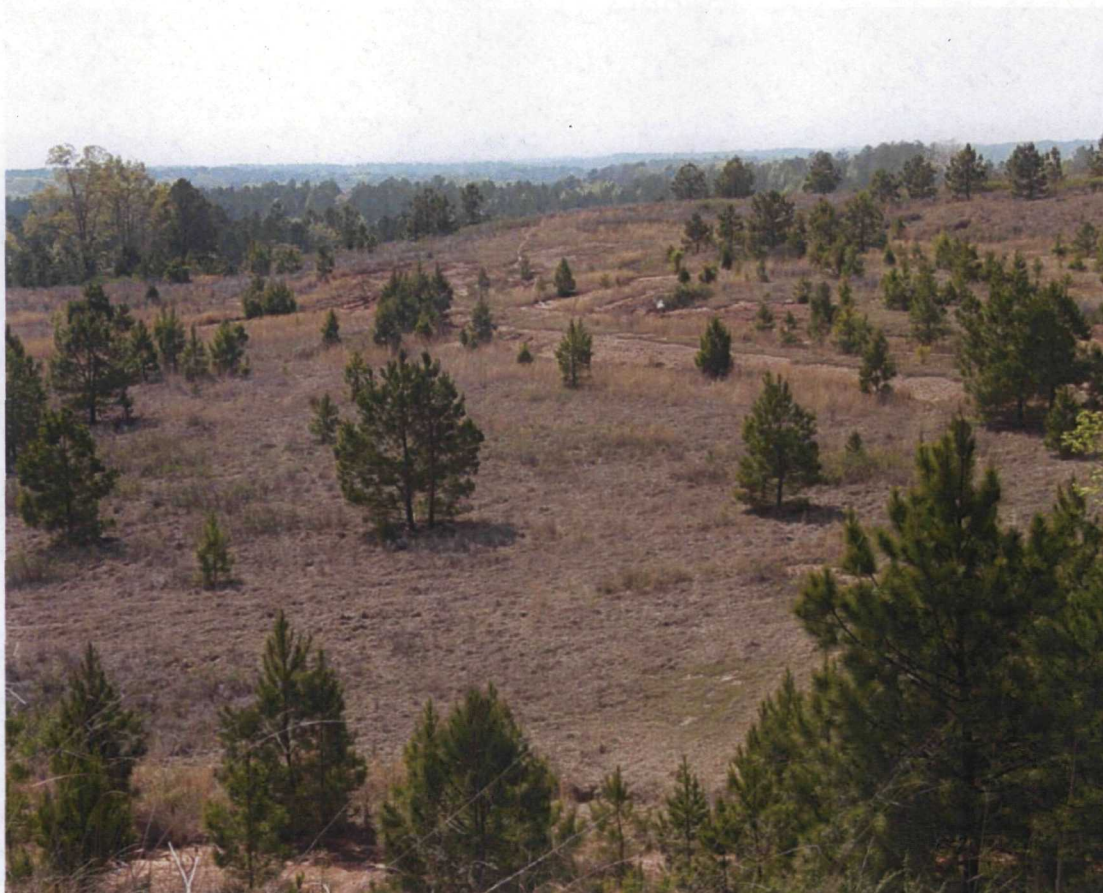
The Rainsford Pit exposed some of the most reactive sulfide rock at the site. The mining company completely backfilled this pit with waste rock and constructed a clay cap over the backfill. The south and west sides of this facility were not inspected due to time limitations. The top, north, and east sides were found to be in good condition with a well vegetated cap. There are minimal concerns regarding this part of the site at this time; however, it is expected that portions of the fill above the water table will turn acid if they have not already done so.

**Figure 22.** Photograph taken from the top of the Permanent Pad looking to the southwest at the Rainsford Pit area (the flat area in the lower 2/3 of the photograph).

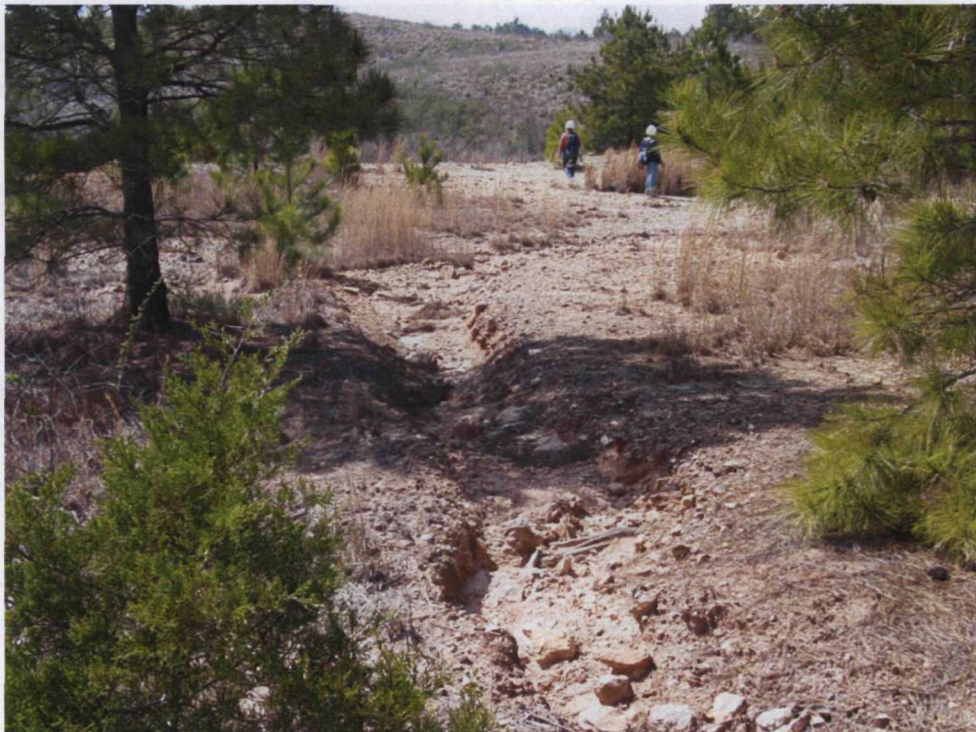
**Figure 25. Shallow erosion gully formed in an un-reclaimed area on the gently sloping top of the Industrial Solid Waste Landfill.**

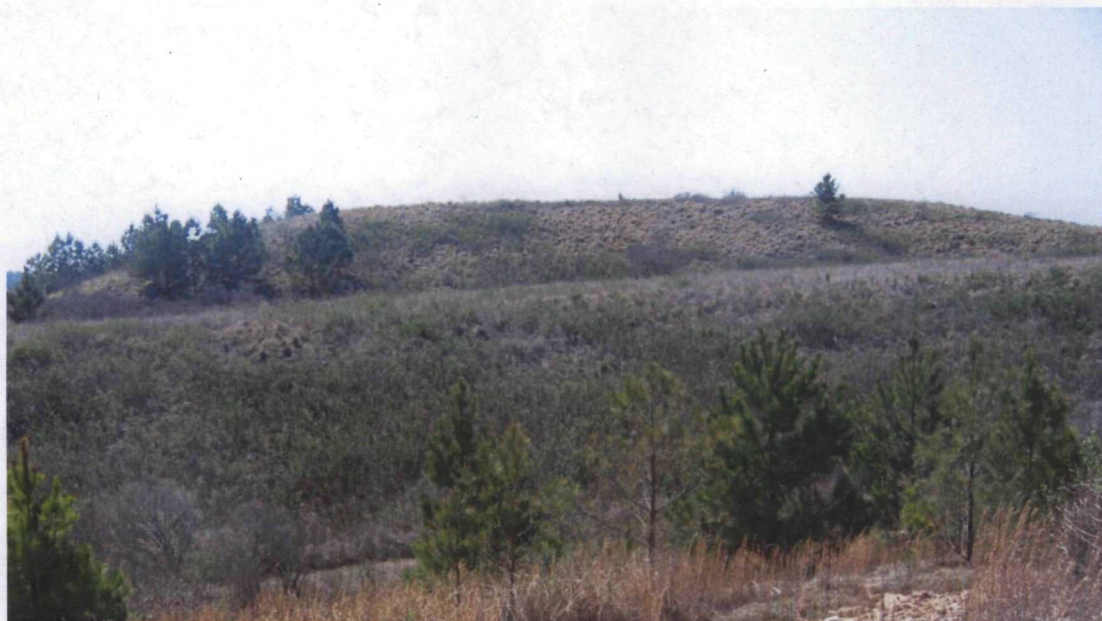
**Figure 27. Photograph of the east slope of the Permanent Heap Leach Pad.**

Seepage from the liner drains to the south and discharges through geomembrane-lined troughs into the Permanent Heap Pregnant Pond and the Permanent Heap Rinse Pond. The seepage is acidic and likely has clogged the lower flow pathways. New acid seeps have formed along the south toe of the pad as seen in Figures 27 and 28. Other problems with this facility are ruts on the cap due to trespass ATV use, and erosion of the south side down chute. The down chute is a steeply inclined ditch which takes clean storm water from the mid-slope berm down to the base of the slope for discharge to receiving waterways. The bedding under the riprap has eroded out and caused the riprap to be dislodged. Erosion is cutting into the cap. On the northwest side of the facility is a second down chute. This chute is less steep but is constructed from acid fill so it is partly barren of vegetation and is likely a source of acid runoff. The disturbed areas lead to increased infiltration and acid generation.

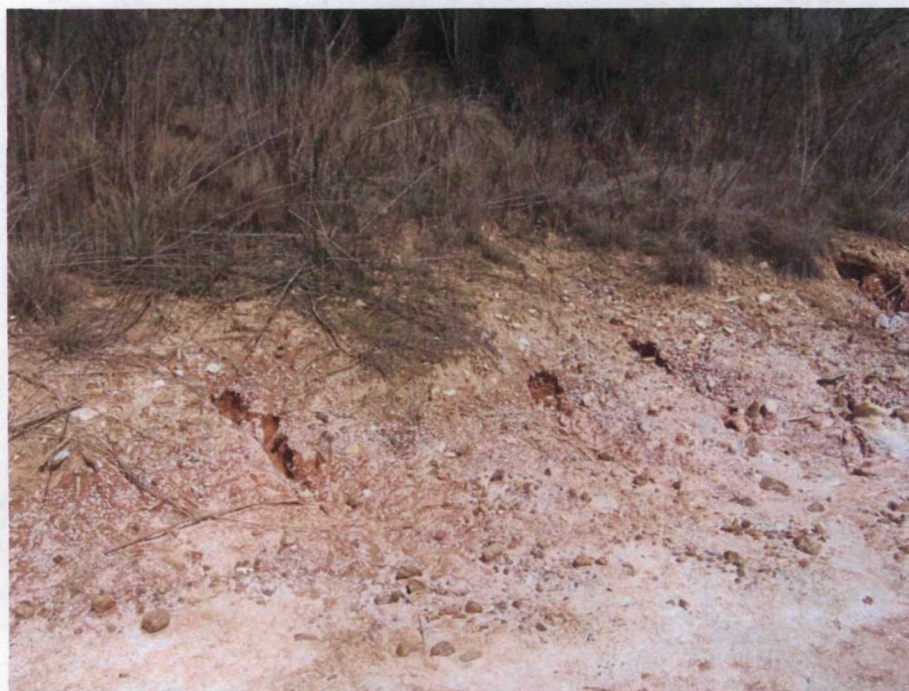
The acid seeps on the south side of the heap are a concern. They will expand and erode the cap. If water levels in the heap rise due to clogging of the lower layers of spent ore with iron hydroxide precipitates, then the stability of the slope could be jeopardized. Further evaluation of the problem is needed.

**Figure 28. Acid seepage killing vegetation and causing piping like internal erosion at the south toe of the Permanent Heap Leach Pad.**

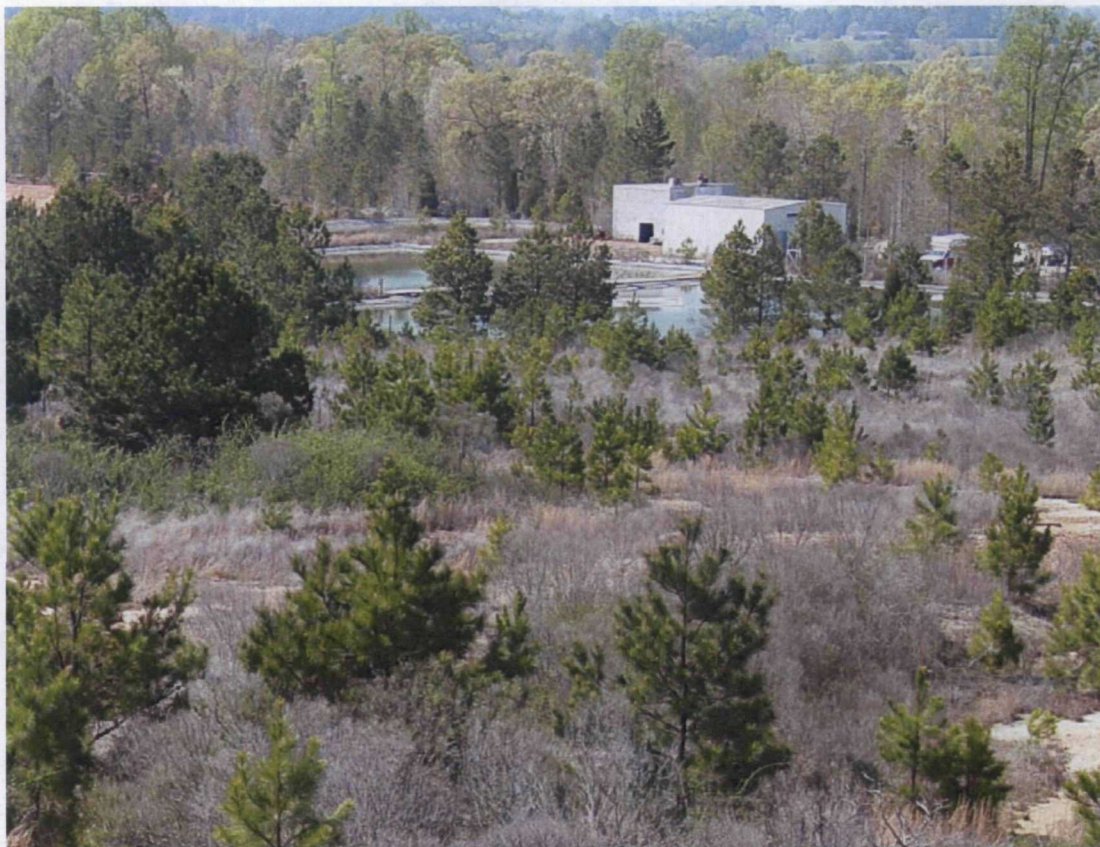
The Reusable Heap Leach Pad was constructed with an asphalt liner. It covers an area of approximately 6 acres. It appears that about 15 feet of spent ore was left on the pad. The area has been capped and the vegetation is in good condition except for one small seep on the northeast edge which has killed vegetation and caused a small amount of erosion. This problem is not significant enough to warrant any other action than monitoring.

**Figure 32. Photograph of the reclaimed Reusable Heap Leach Pad. Disturbed areas at right are rock outcrops which are just outside the limits of the pad.**

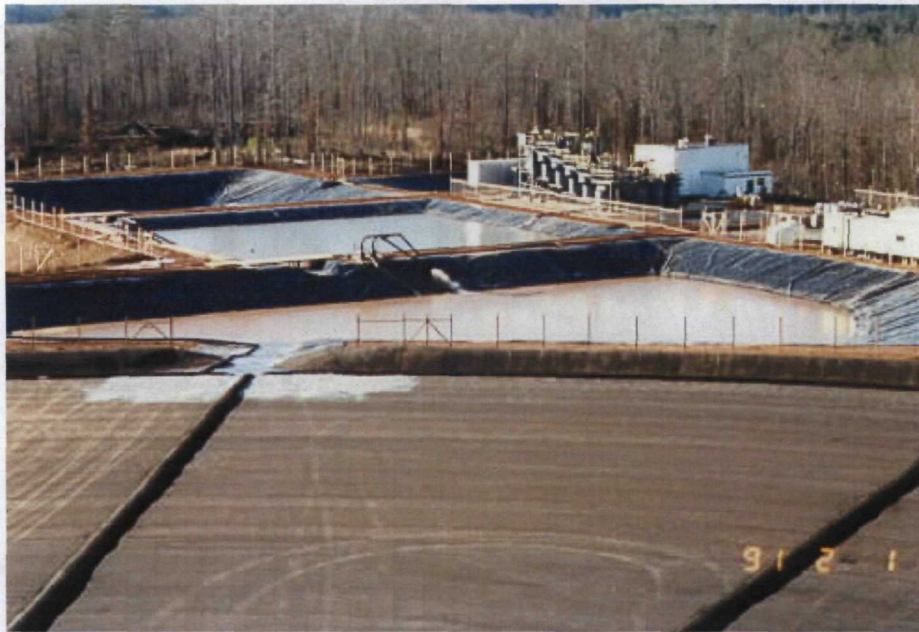
**Figure 33. Photograph showing the Reusable Leach Pad (lower half of photograph) at the Barite Hill mine prior to ore placement in 1991 (From the Scotia International Website). Note how the pad is designed to discharge cyanide solution seepage to the Plant Pregnant Pond.**

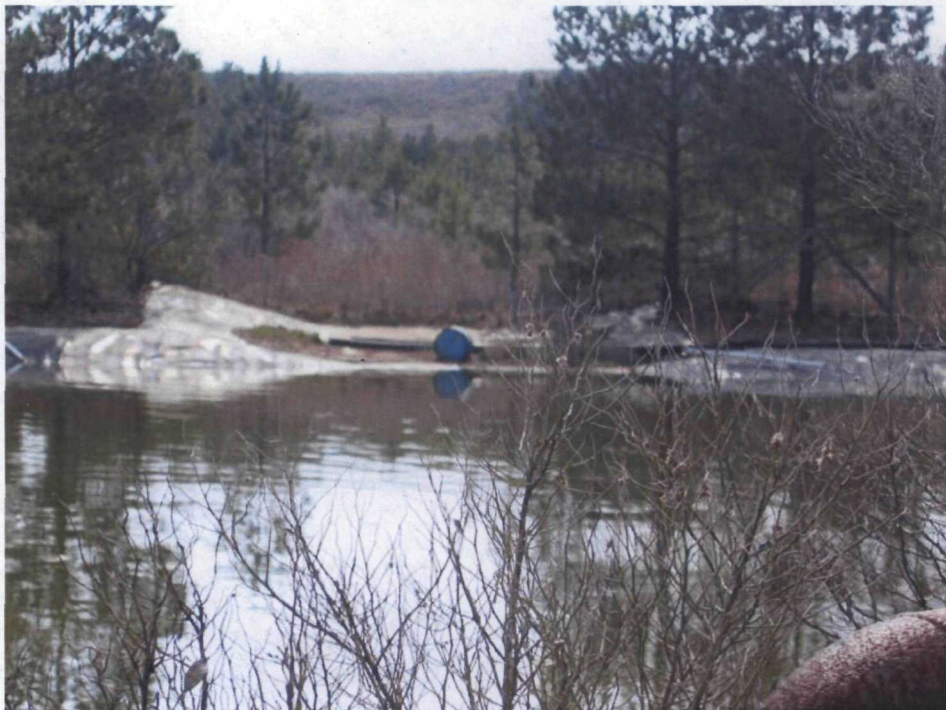
**Figure 34. Photograph looking across the Plant Pregnant Pond showing the geomembrane-covered seepage outlet from the Reusable Heap Leach Pad.**

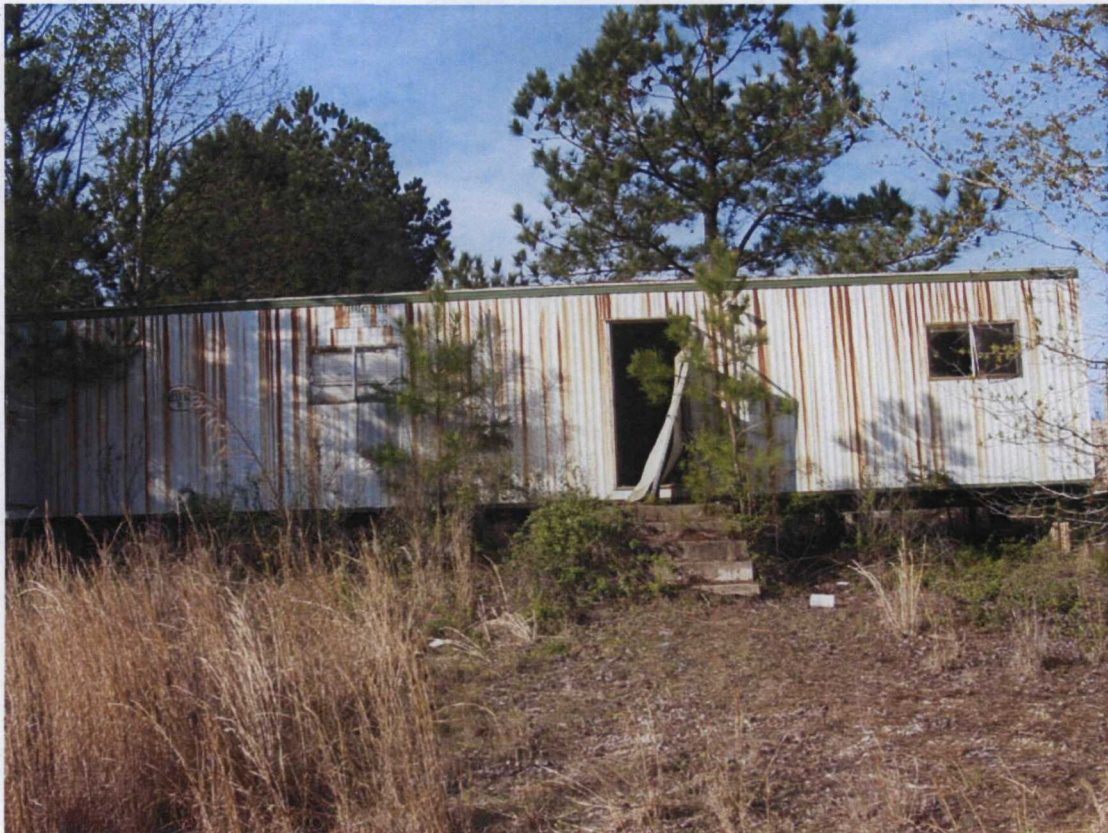
The mine office is a modular trailer 12 feet by 56 feet long. There is an air conditioning unit on one end of the building. An ice chest, typical of that seen at grocery stores lies outside behind the building (potential for entrapment). The office building has broken windows and inside much of the furniture has been broken, turned upside down and papers scattered about. It appears that this is the work of trespassers. Despite the trespass damage and disarray, the project records were found inside the building. The land ownership files were found and given to Mr. Francendesce. Technical reports and relevant project maps were removed by the Bureau of Reclamation. The recovered reports are listed in the references section of this report, and key project maps have been copied and are included in Appendix A. Time did not allow for all project records and maps to be examined, about 3 hours were spent in the building. There may still be valuable records present that should be gone through.

**Figure 35. The mine office is a modular building structure.**

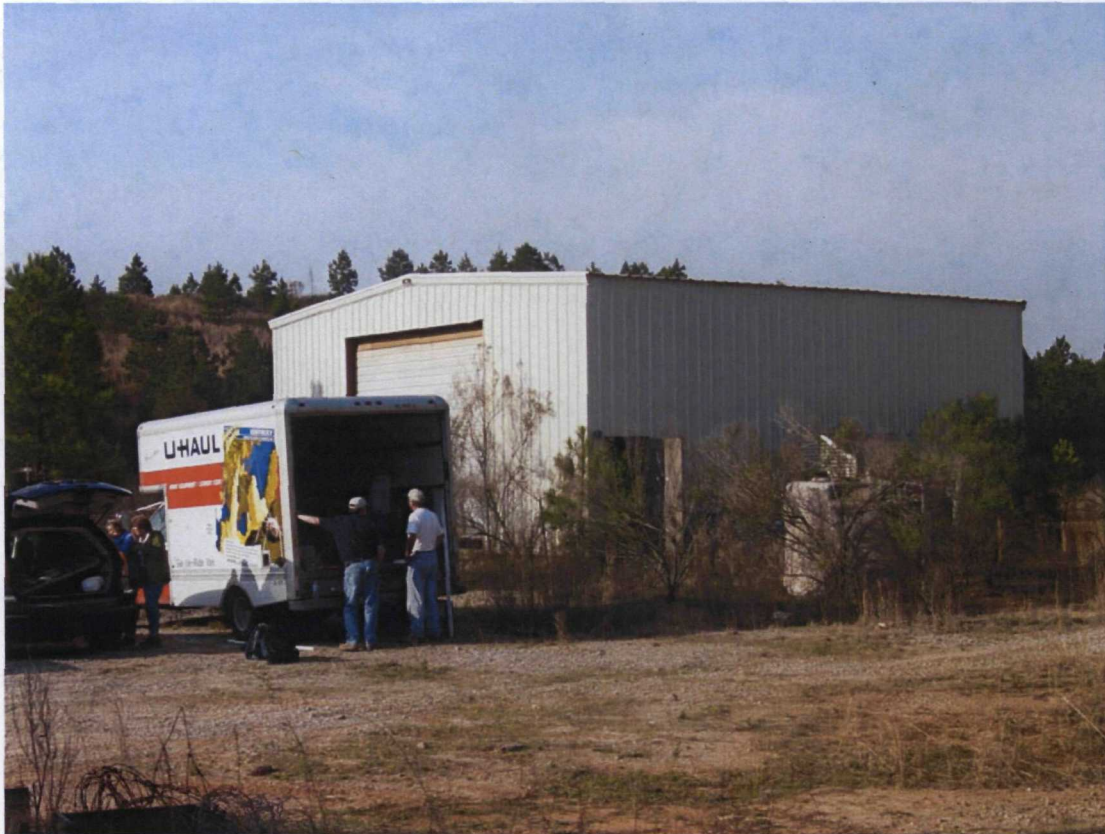
The Water Treatment Plant is a steel (column and beam) structure. It is insulated and sheathed with metal siding and has a metal roof. The garage door is damaged and inoperable. Inside the building were two wood pallets containing both opened and unopened bags of caustic soda. Liquid acid and caustic solutions were stored nearby in tanks outside of the building. These chemicals were disposed of during the initial Emergency Response by EPA.

**Figure 36. Water Treatment Plant structure contained a 25 gpm treatment system for treating process waters and landfill leachate to meet discharge standards.**

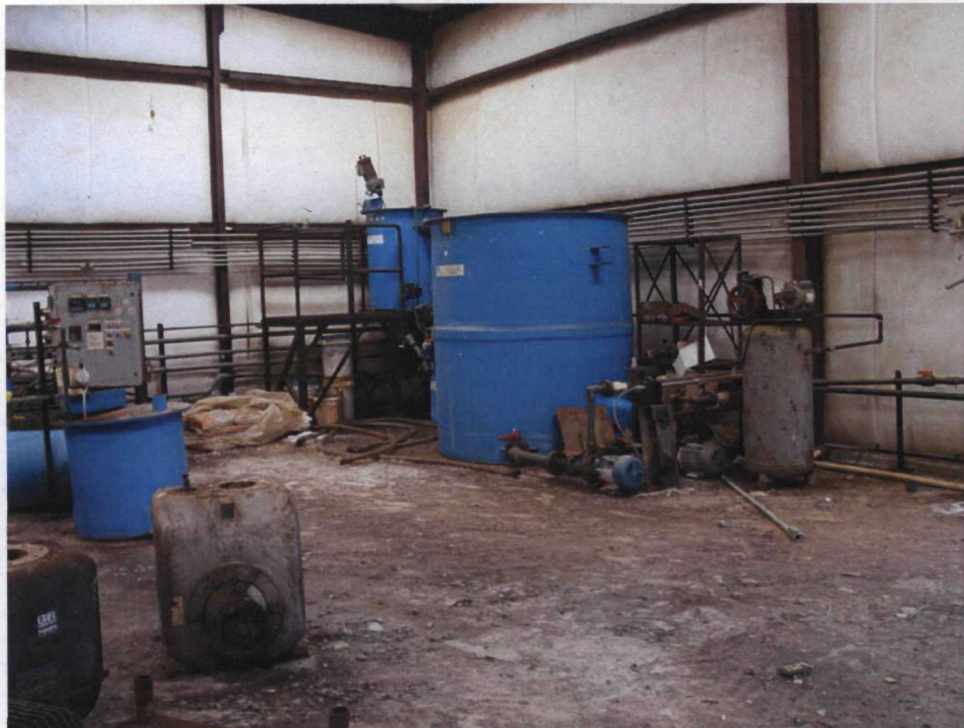
**Figure 37. View of tankage and motors remaining inside the partially dismantled Water Treatment Plant.**

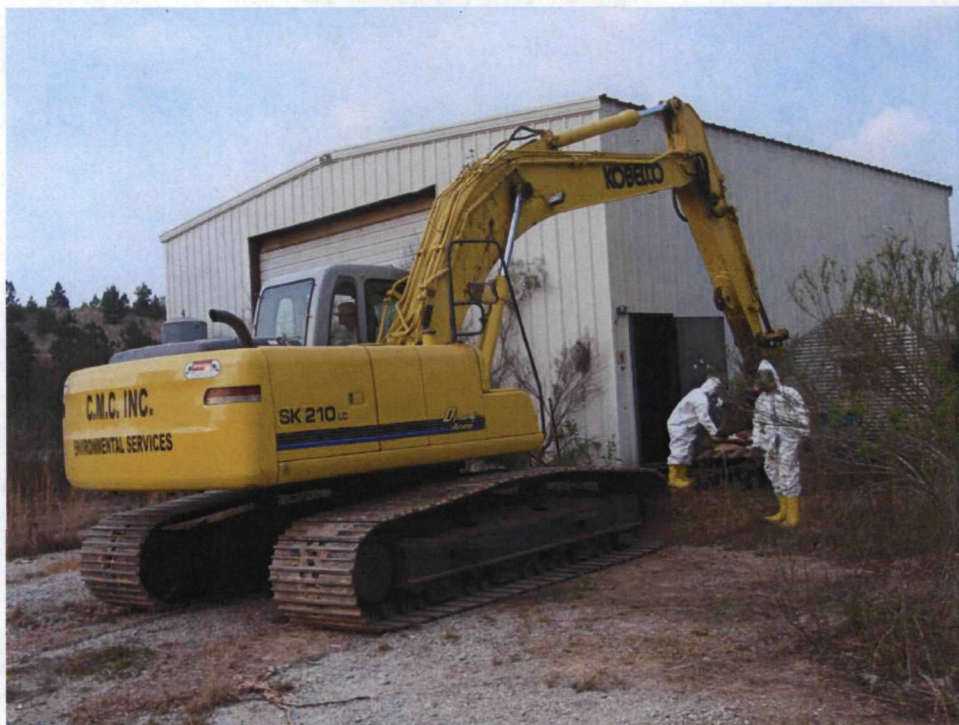
**Figure 38. Workers removing sacks of sodium hydroxide from the Water Treatment Plant as part of the Emergency Response.**

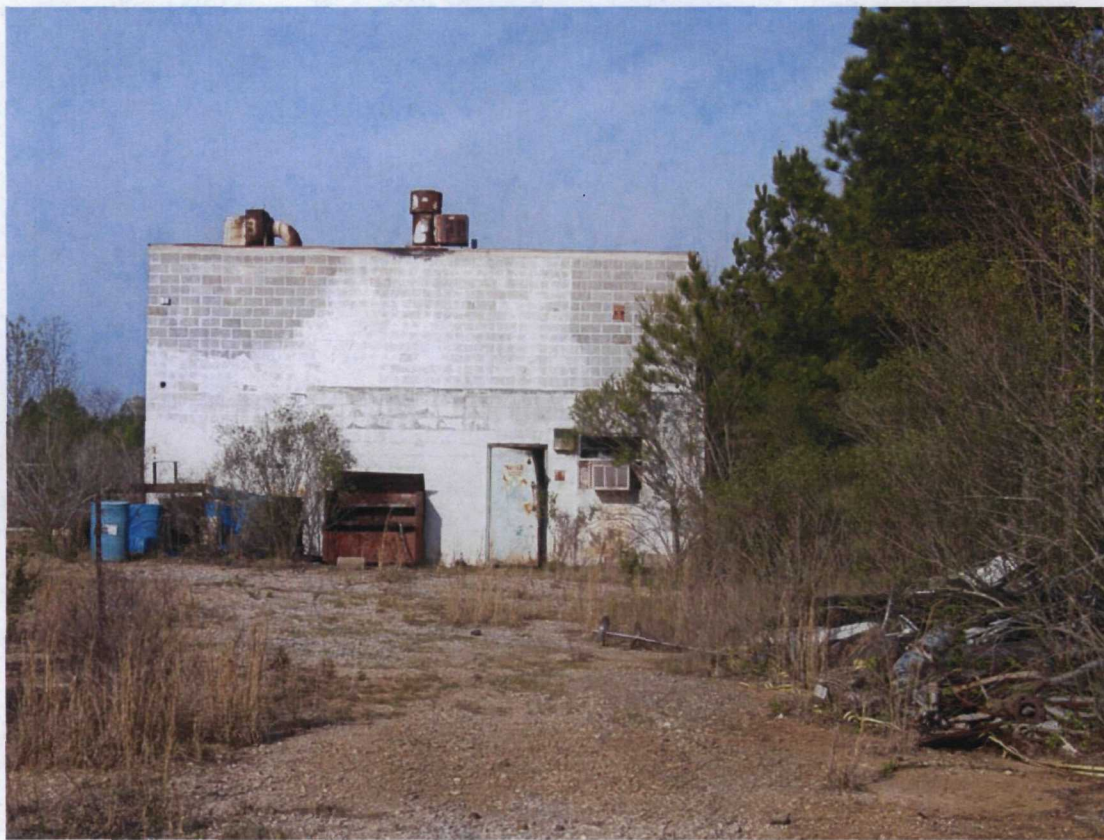
**Figure 39. The gold assay and melting furnace building. Note fume ventilation system components on the roof.**

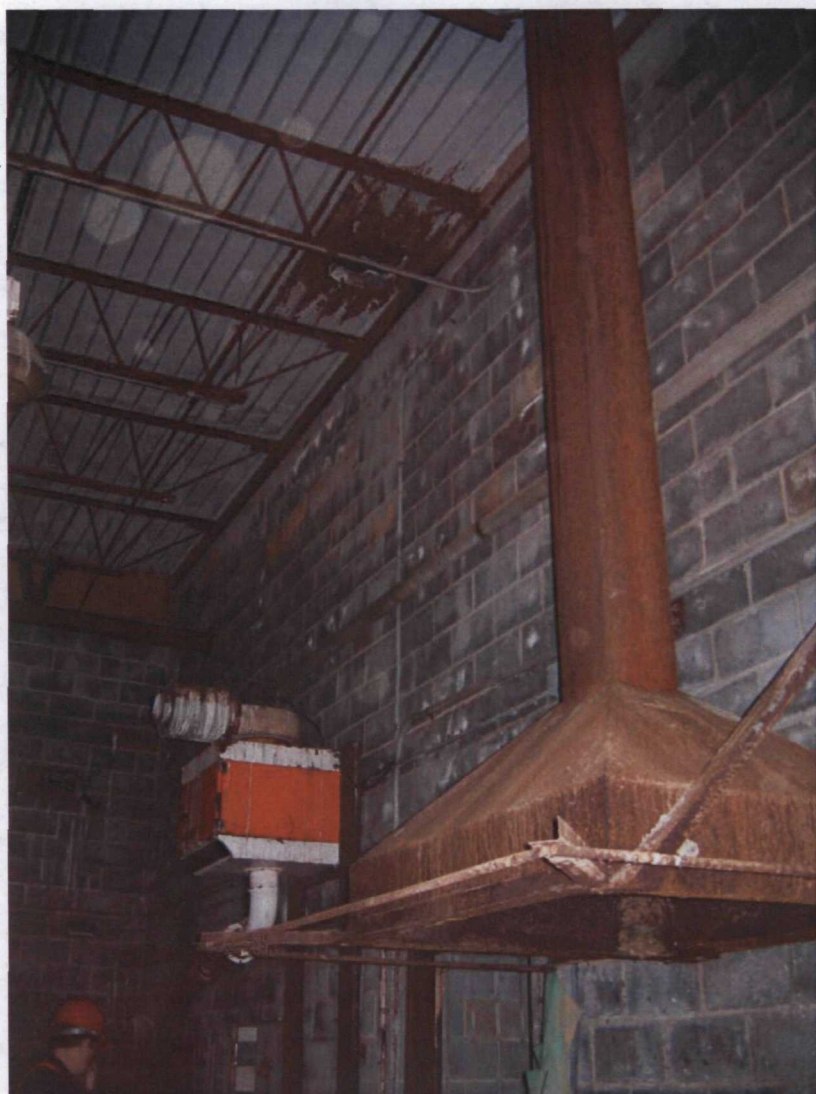
**Figure 40. Two fume ventilation systems used for the fire assay process. At left is a portion of the fume ventilation system for the small melting/assay furnace, at right is the fire assay acid fume hood and ventilation duct leading to the roof.**

Three separate ventilating systems were found in the building. Two appear to be a part of the assaying operation (Figure 40), the third system was associated with the gold and silver production (Figure 41). All of the ventilation systems have the potential to contain heavy metal oxide flue dust. Contamination was evident in the assay systems, no attempt was made to open the larger production ventilation system. A small assay/melting furnace was on the ground just outside the building. The vent opening at the top of the small furnace also appeared to be coated with metal oxides.

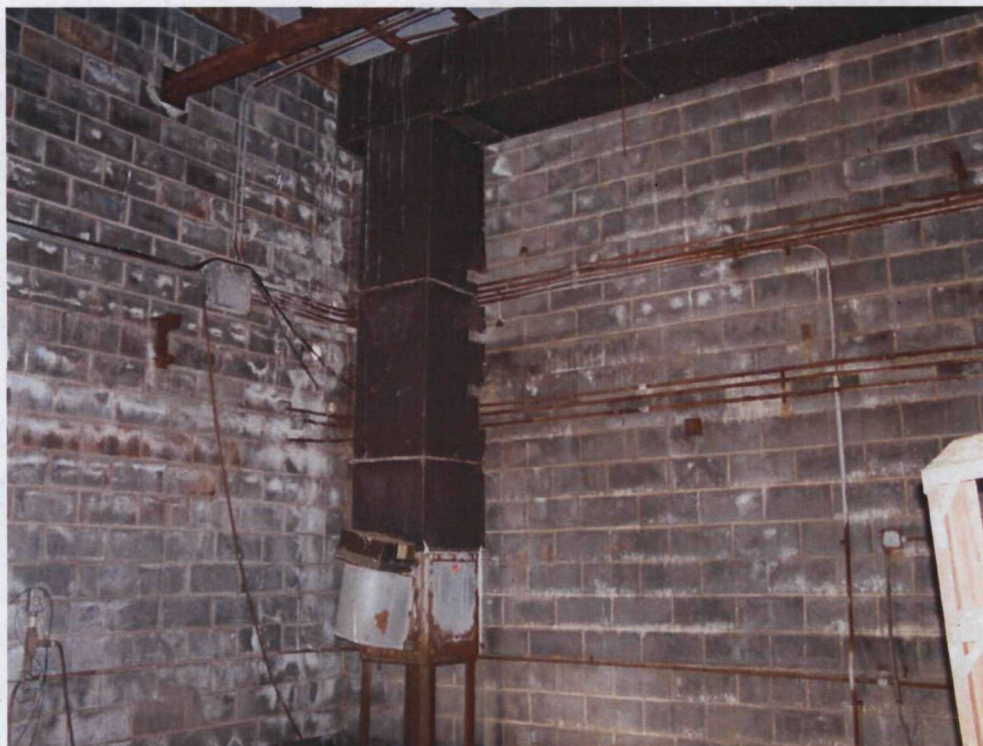
**Figure 41. Ducting for large fume ventilation system used during gold production.**

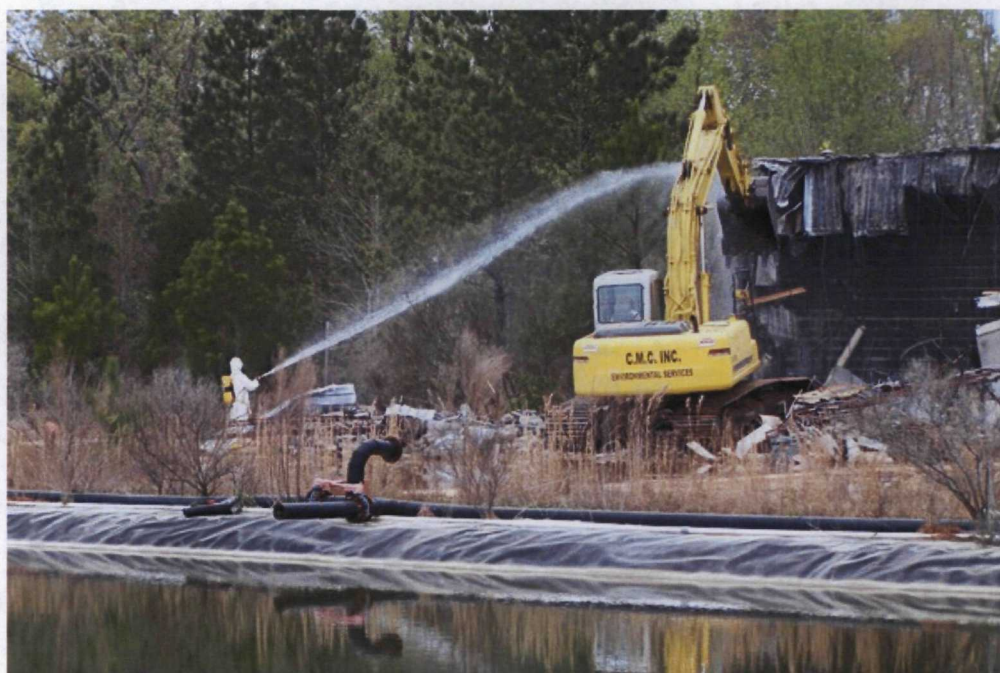
**Figure 42. Demolition of the Gold Assay and Melting Furnace Building on March 30, 2007 as part of the Emergency Response.**
